Section 3:

CATEGORIES OF MITIGATION OPTIONS: WALLS & FOUNDATIONS

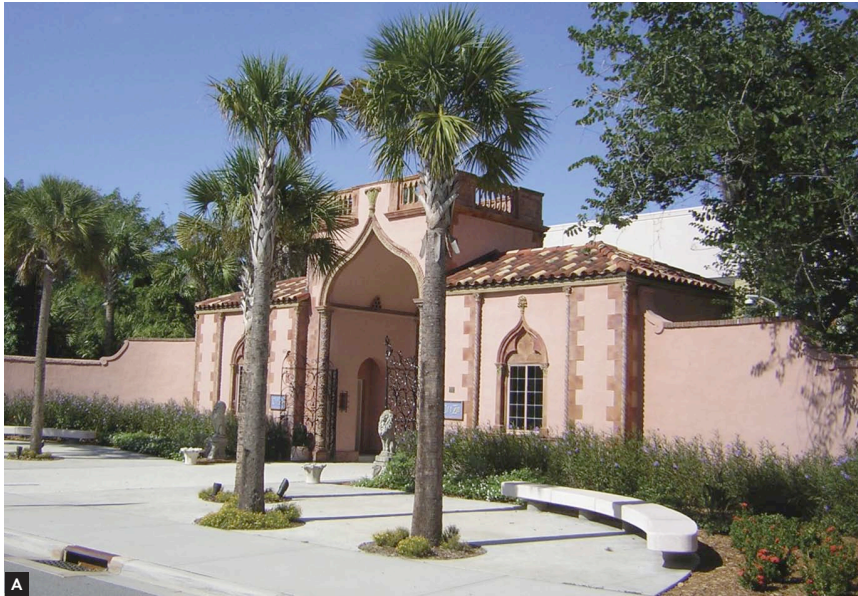
A) Front Elevation of Ringling Ca d'Zan Gatehouse; B) Rafter tie down straps/anchors in masonry wall;
C) Rafter tie down straps/anchors. 1926 Ringling Estate, Ca d'Zan, Sarasota

Connections (straps, clips and other connectors) installed to improve anchorage of roof framing to walls and walls to foundation should be concealed. Existing exterior finishes should be carefully removed and reinstalled to accomplish installation. If these connections can be installed at

the same time as reroofing, a small area of the roof deck can be removed at the wall line to facilitate installation of the required straps – without affecting interior or exterior finishes.

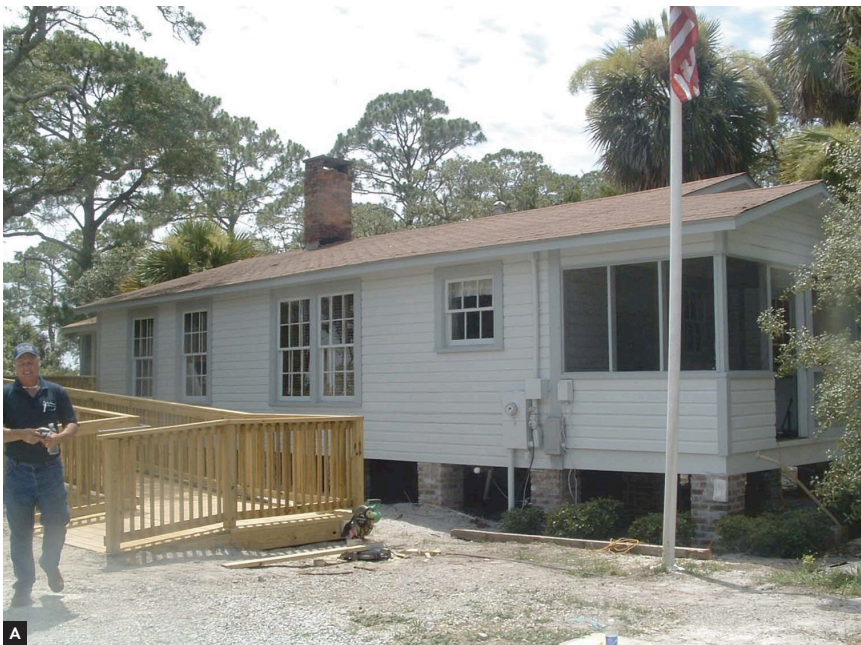
A slab on grade foundation is a single, continuous layer of concrete with turned-down edges that sits directly on the ground and acts as the floor and foundation system. A slab-on-grade foundation is typically reinforced with welded wire fabric and longitudinal steel reinforcement (rebar) in the perimeter footing or turndown and elsewhere where it supports load-bearing partitions. For wood-framed construction, the bottom plate of the wall should be anchored to the slab with anchor bolts and washers. In order to retrofit, drill through the wall's sill plate into the concrete slab to anchor the wood-framed walls. Install 5/8" retrofit anchors with minimum 3"x3"x1/8"; washers every 16 inches and within a foot of each corner. Again, it is important to install these products following manufacturer's recommendations. Threaded rods set in epoxy adhesive are

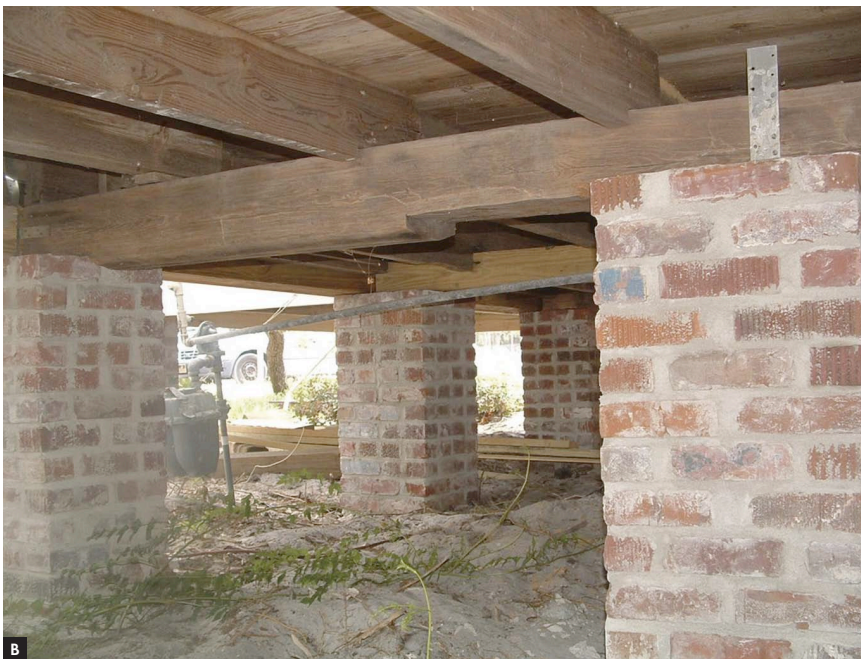
B

A) 1937 Maddox House in Port St. Joe; B) Sill Beam Tie Downs Trap to New Masonry Piers

The most common anchoring system for wood walls and wood floor systems to foundations is the use of metal straps or connectors. These straps and connectors are easily attached to masonry foundations with masonry screws or bolts. It is important to install these products following manufacturer's recommendations.
